## Cycling Accident Risks

### Accidents involving cyclists

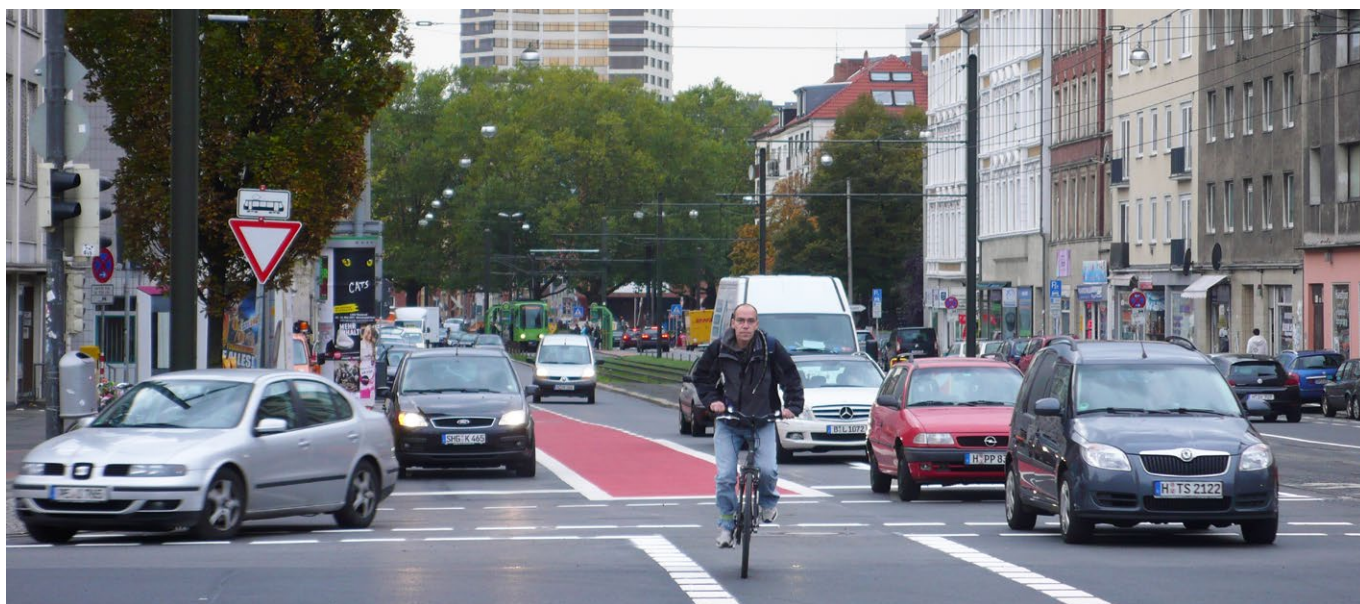
*Safety by visibility – re-designed intersection in Hannover*

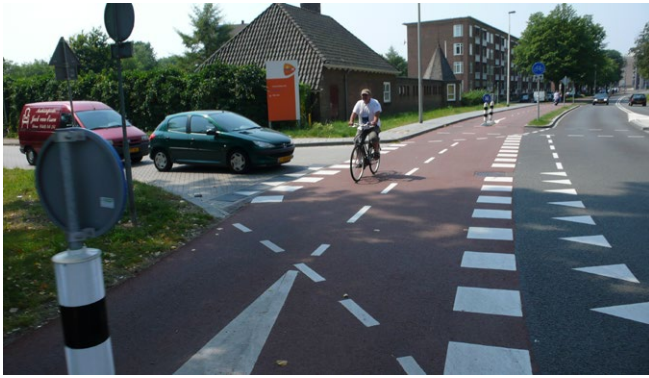
*Safe crossing of a one side, two directions cycleway at side road (Arnhem, Netherlands)*

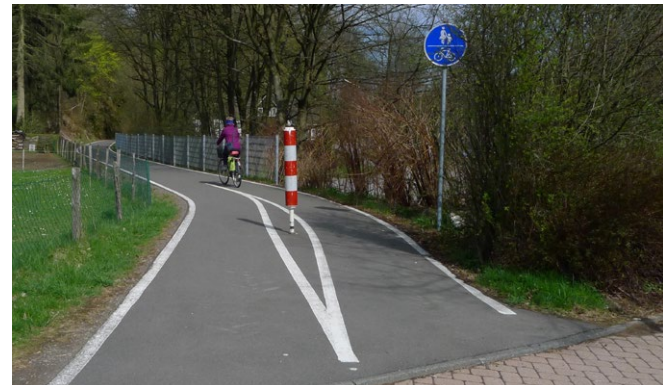
*Visual contrast at bollard to prevent one-sided accidents (Cologne region)*

Bollards that are to prevent cars from driving or parking on the pavement pose a significant risk because cyclists often do not see them, especially when they are in a group of cyclists. The Dutch cities of Zwolle and Amersfoort therefore have created websites where people can report bollards that are redundant (e.g. [www.zwolle.nl/fietspalen](http://www.zwolle.nl/fietspalen)). They received 3500 suggestions for the

removal and 500 for the relocation of bollards. Amersfoort took immediate response by taking 90 bollards off the cycle paths after winter road maintenance.

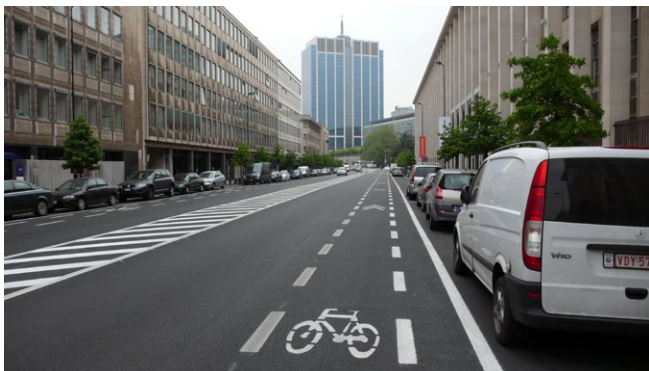
Brussels: Transformation of a four lane main street to a two lane street with cycle lane by new road markings

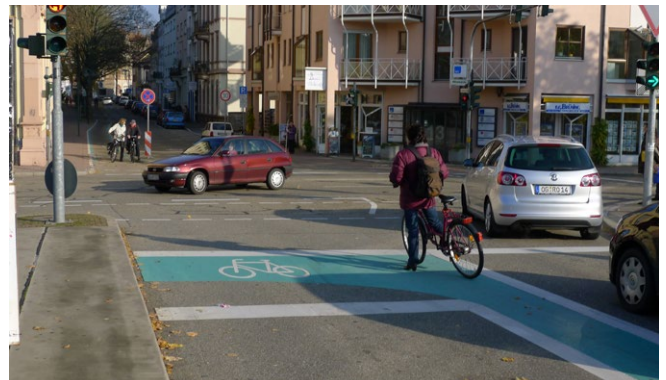
Bicycle box for safe turning left (Offenburg)

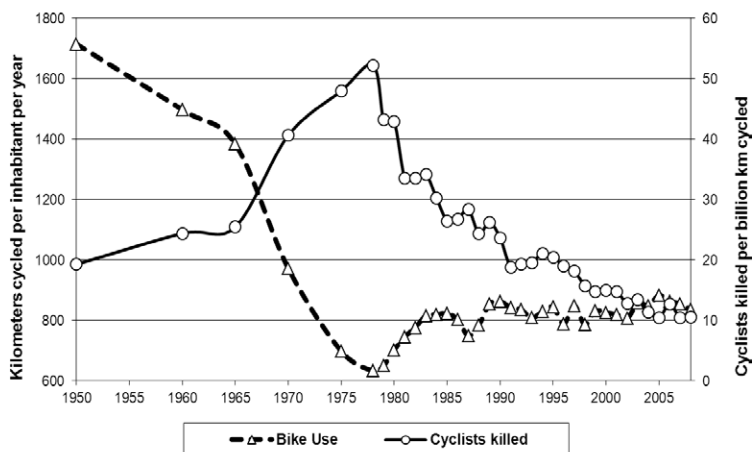
Long term trends of bike use and fatalities while cycling in the Netherlands. Source: Pucher, J., Buehler, R. (2008): *Making Cycling Irresistible. Lessons from the Netherlands, Denmark, and Germany. Transport Reviews, Vol. 28, No. 4, 2008, pp. 495-528.*

The long-term development of cycling and cyclist fatalities in the Netherlands clearly shows that the risk for cyclists increases as motorised traffic volumes increase. Cycling safety was then increased through the contin-

uous expansion of the cycle networks since the 1970s, which made cycling much safer and at the same time caused cycling levels to rise.
